# Fire-resistance test on fire collars protecting a concrete floor slab penetrated by services

## Test Report

**Author:** Chris Wojcik  
**Report number:** FSP 1875

## Sponsored Investigation No. FSP 1875

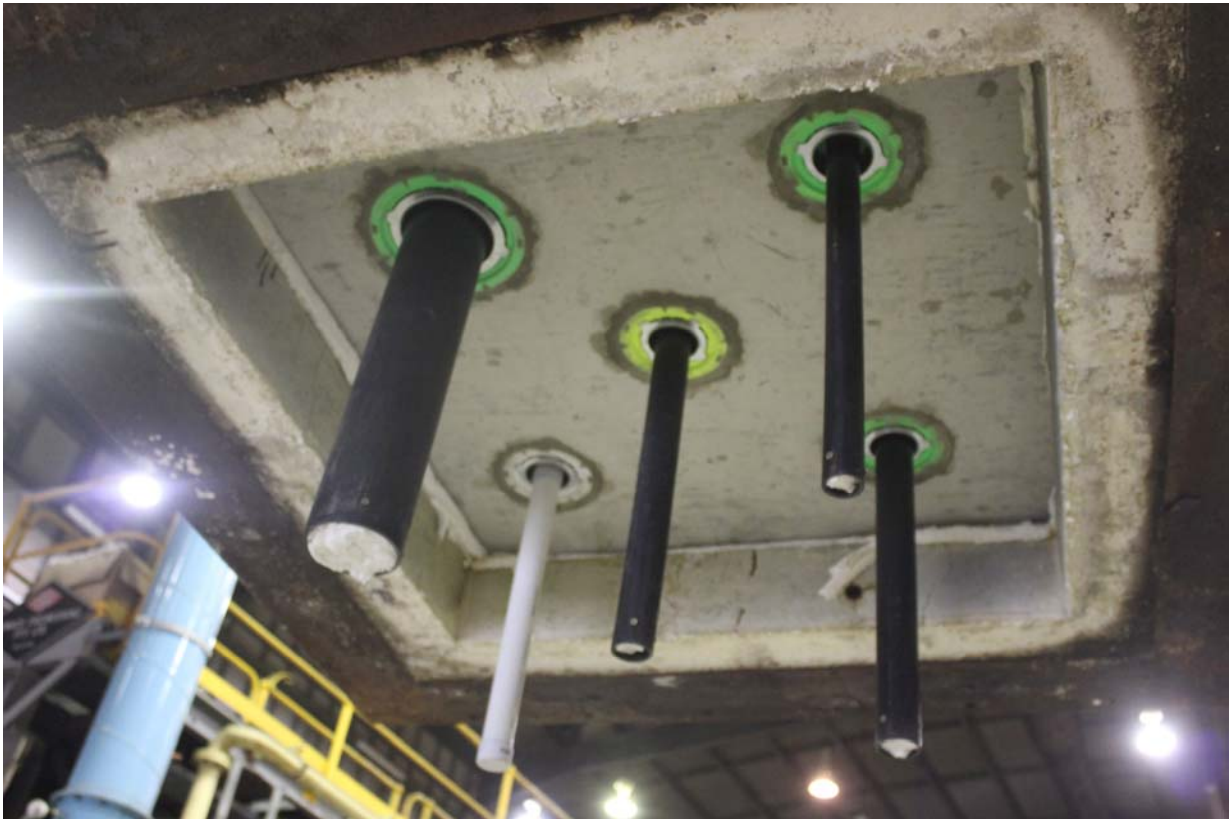
**PHOTOGRAPH 1 – EXPOSED FACE OF SPECIMENS PRIOR TO TESTING**

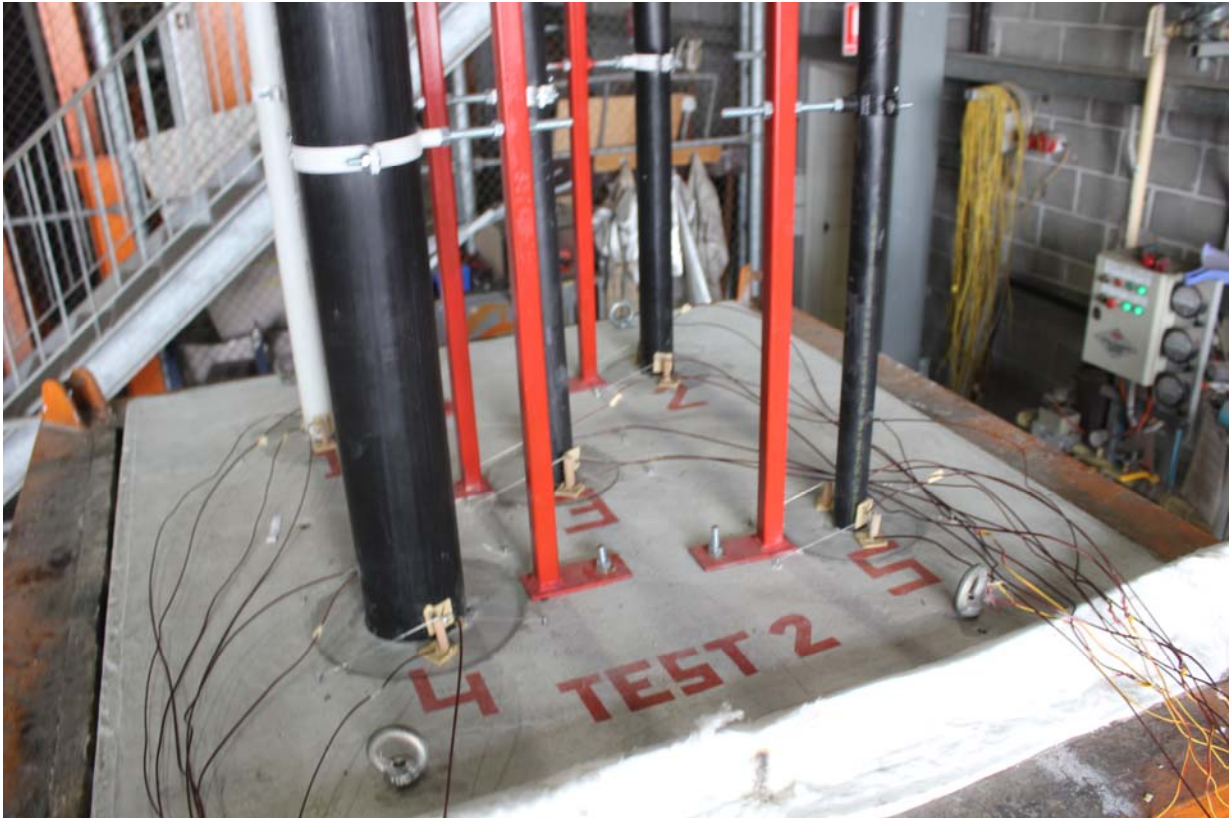
**PHOTOGRAPH 2 – UNEXPOSED FACE OF SPECIMENS PRIOR TO TESTING**

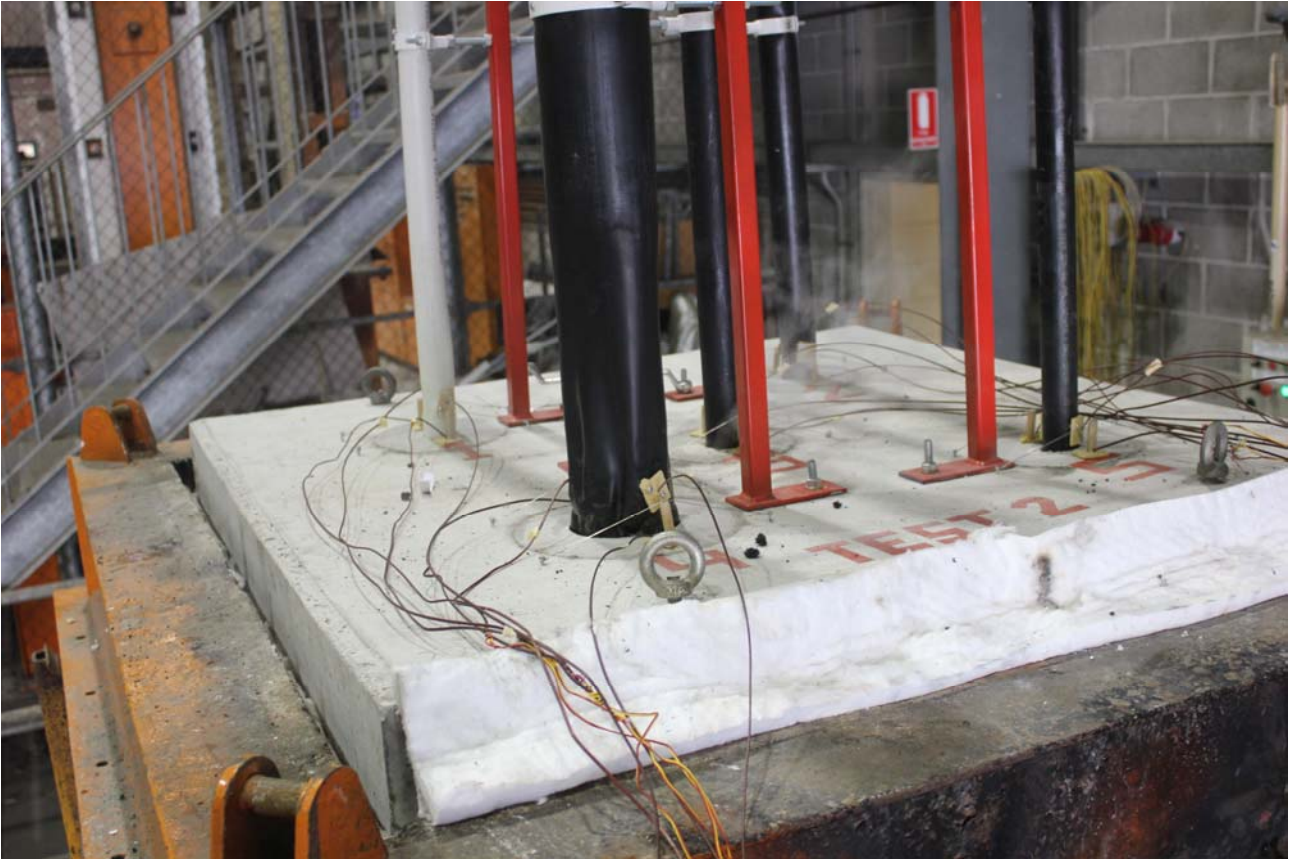
**PHOTOGRAPH 3 – SPECIMENS AFTER 60 MINUTES OF TESTING**

<b>Time</b>	<b>Observation</b>
2 minutes -	Smoke is being emitted from end of Penetration 1, 2, and 3.
4 minutes -	Fluing has ceased from Penetration 2 and 3.
5 minutes -	Base of Penetration 1 is starting to distort.
7 minutes -	Base of penetration 2 is starting to distort.
9 minutes -	Base of penetration 4 is starting to distort.
10 minutes -	Light smoke is being emitted from base of Penetration 5.
15 minutes -	Light smoke is being emitted from the ends of Penetration 1 and 4.
30 minutes -	Very light smoke is being emitted from Penetration 4. No smoke is noted on Penetration 1, 2, 3 and 5.
60 minutes -	No visible change.
120 minutes -	No apparent change to the specimen.
180 minutes -	No apparent change to the specimen.
187 minutes -	Maximum temperature rise failure on Slab – Penetration 3.
209 minutes -	Maximum temperature rise failure on Slab – Penetration 4.
210 minutes -	Maximum temperature rise failure on Slab – Penetration 5.

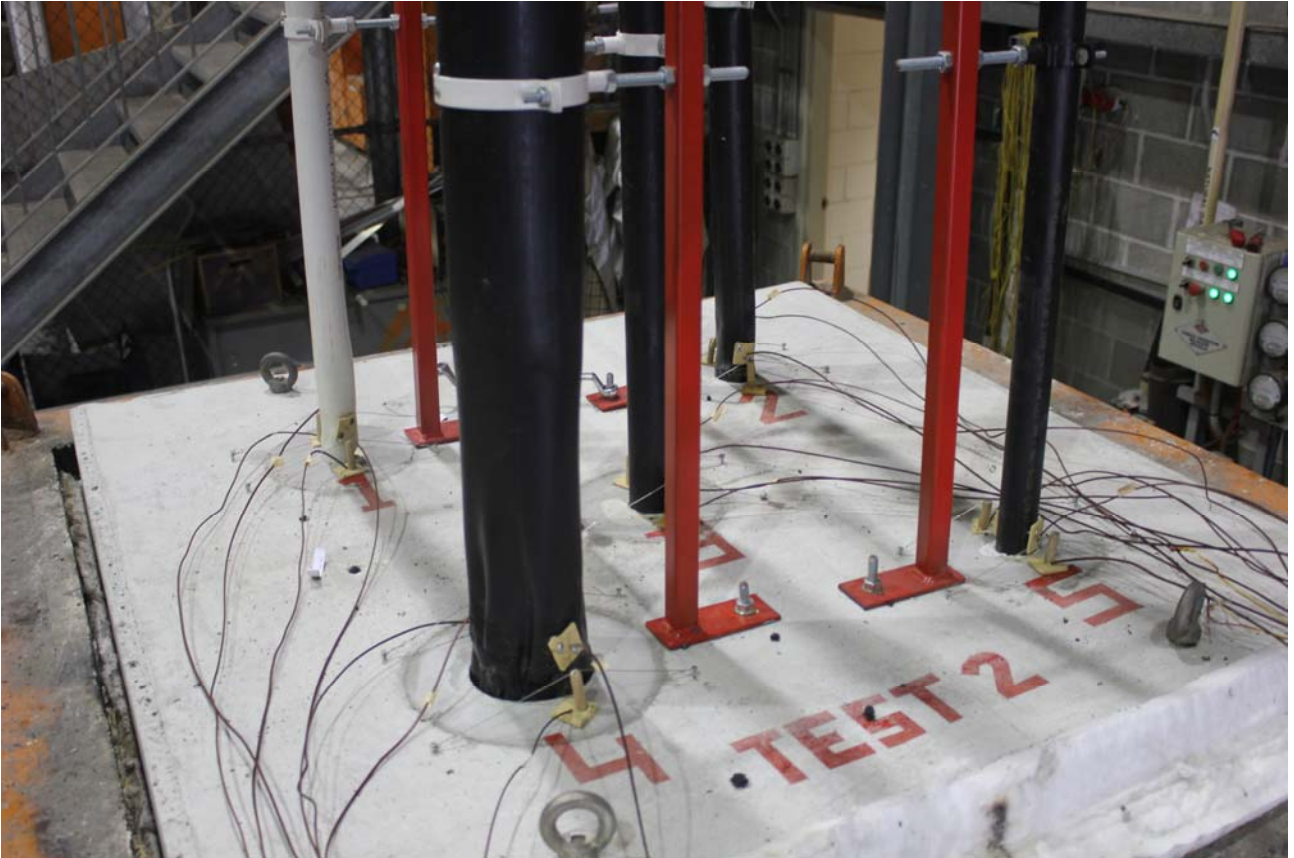
**PHOTOGRAPH 4 – SPECIMENS AFTER 120 MINUTES OF TESTING**

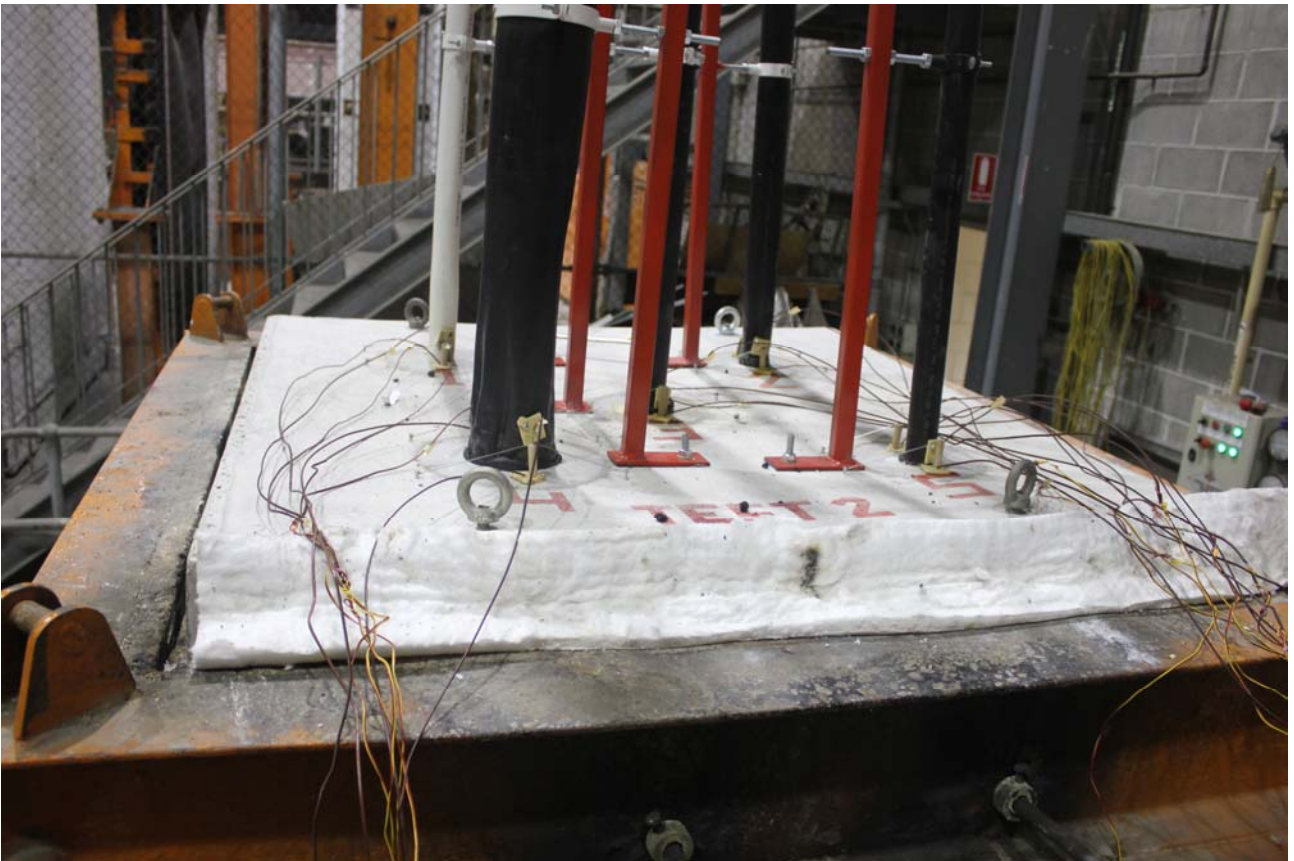
**PHOTOGRAPH 5 – SPECIMENS AFTER 180 MINUTES OF TESTING**

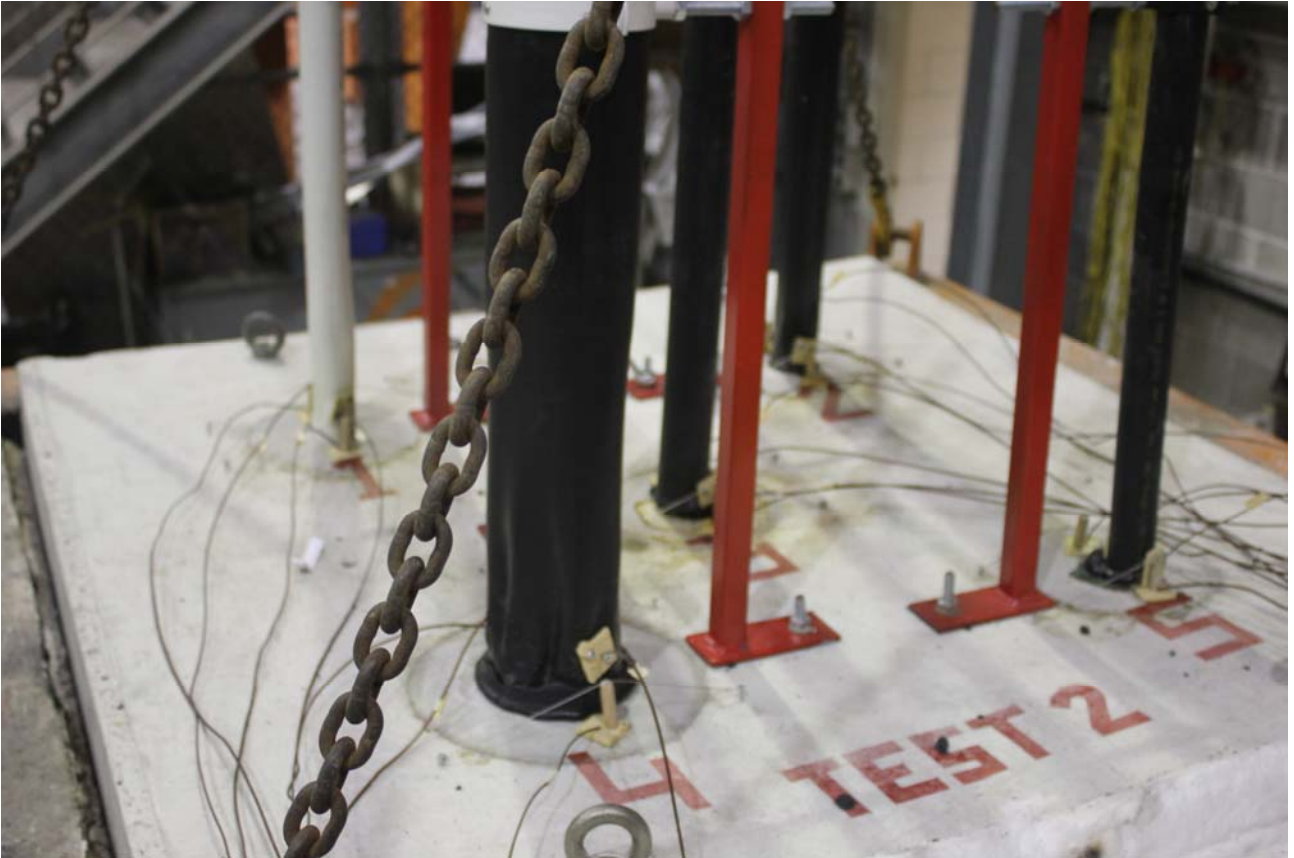
**PHOTOGRAPH 6 – UNEXPOSED FACED OF SPECIMEN AT CONCLUSION OF TESTING**

222 minutes -	Maximum temperature rise failure on Slab – Penetration 1.
225 minutes -	Base of Penetration 5 is melting and bubbling.
238 minutes -	Maximum temperature rise failure on Slab – Penetration 2.
241 minutes -	Test terminated.

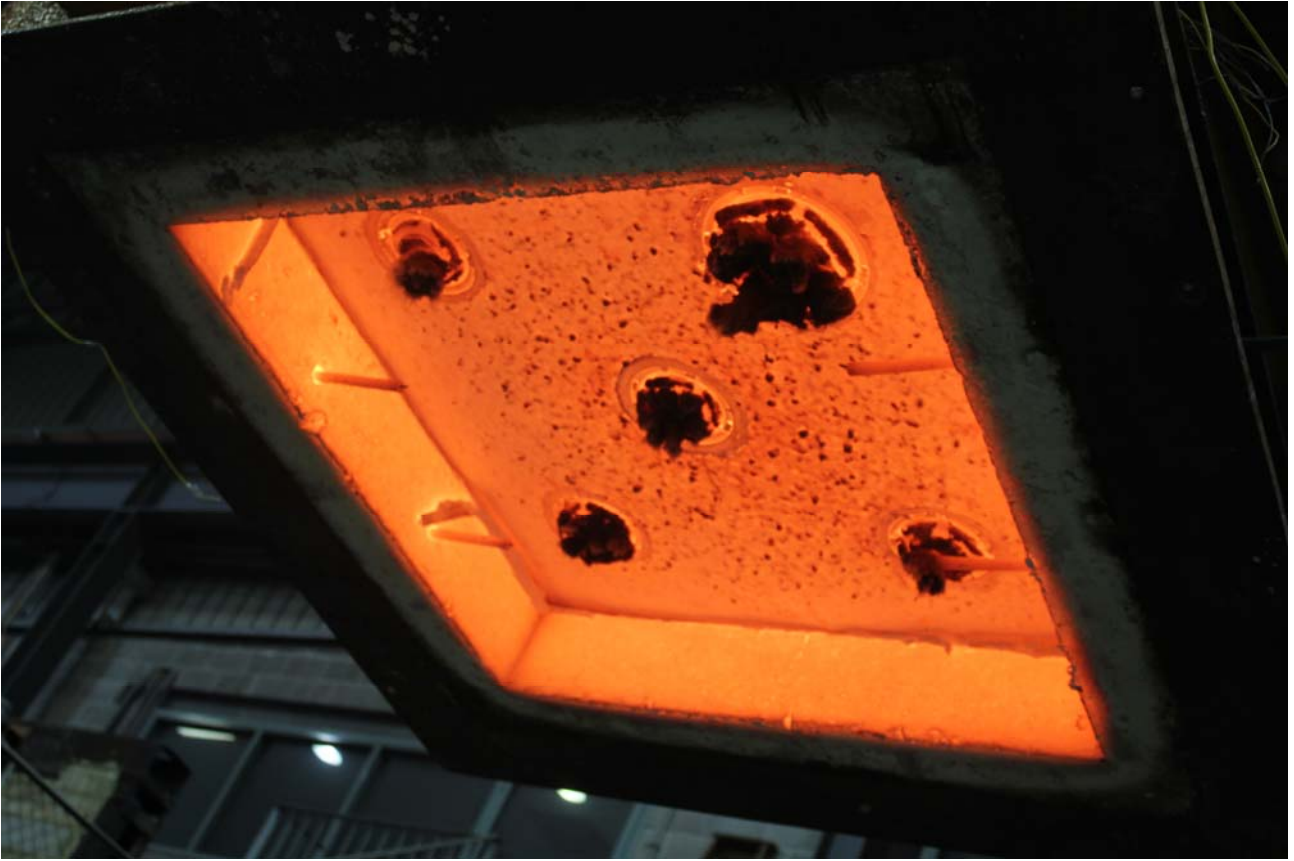
**PHOTOGRAPH 7 – EXPOSED FACE OF SPECIMENS AT CONCLUSION OF TESTING**

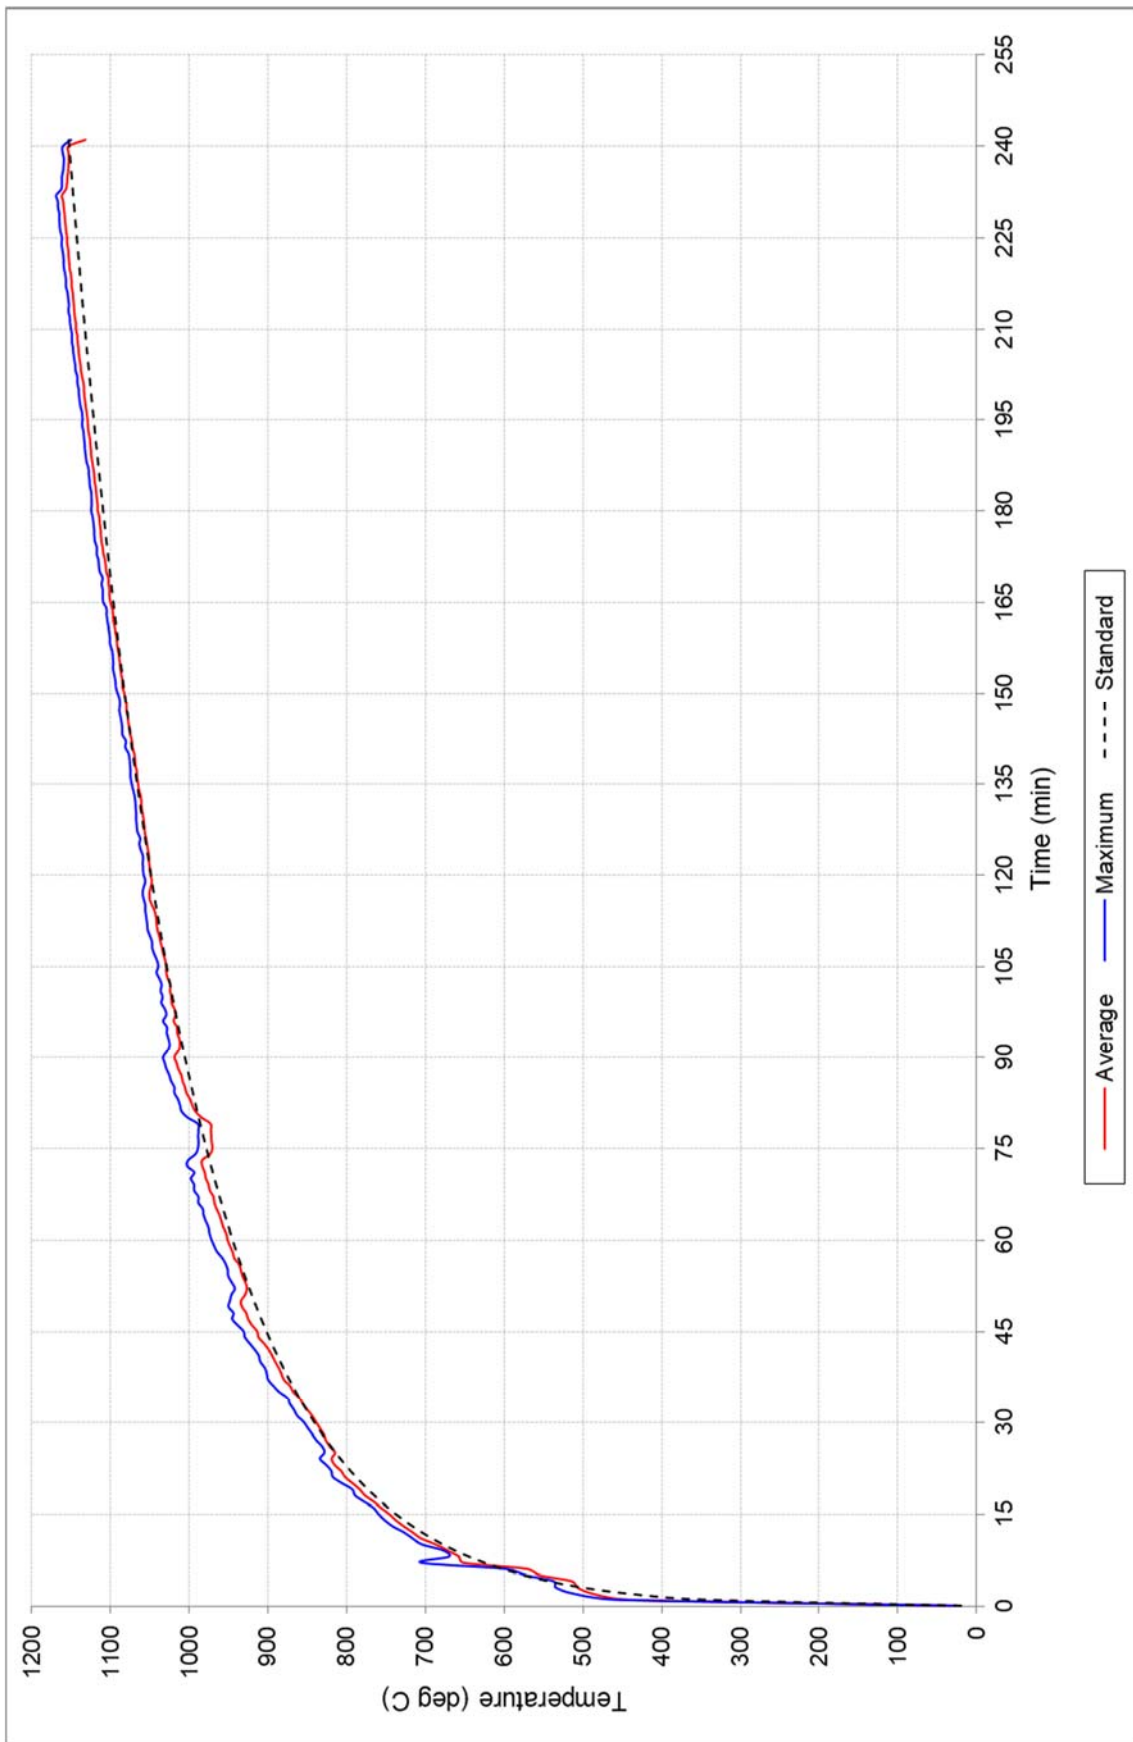
FIGURE 1 – FURNACE TEMPERATURE

Figure 1 shows the standard curves of temperature versus time for heating the furnace chamber and the actual curves of average and maximum temperature versus time recorded during the heating period.

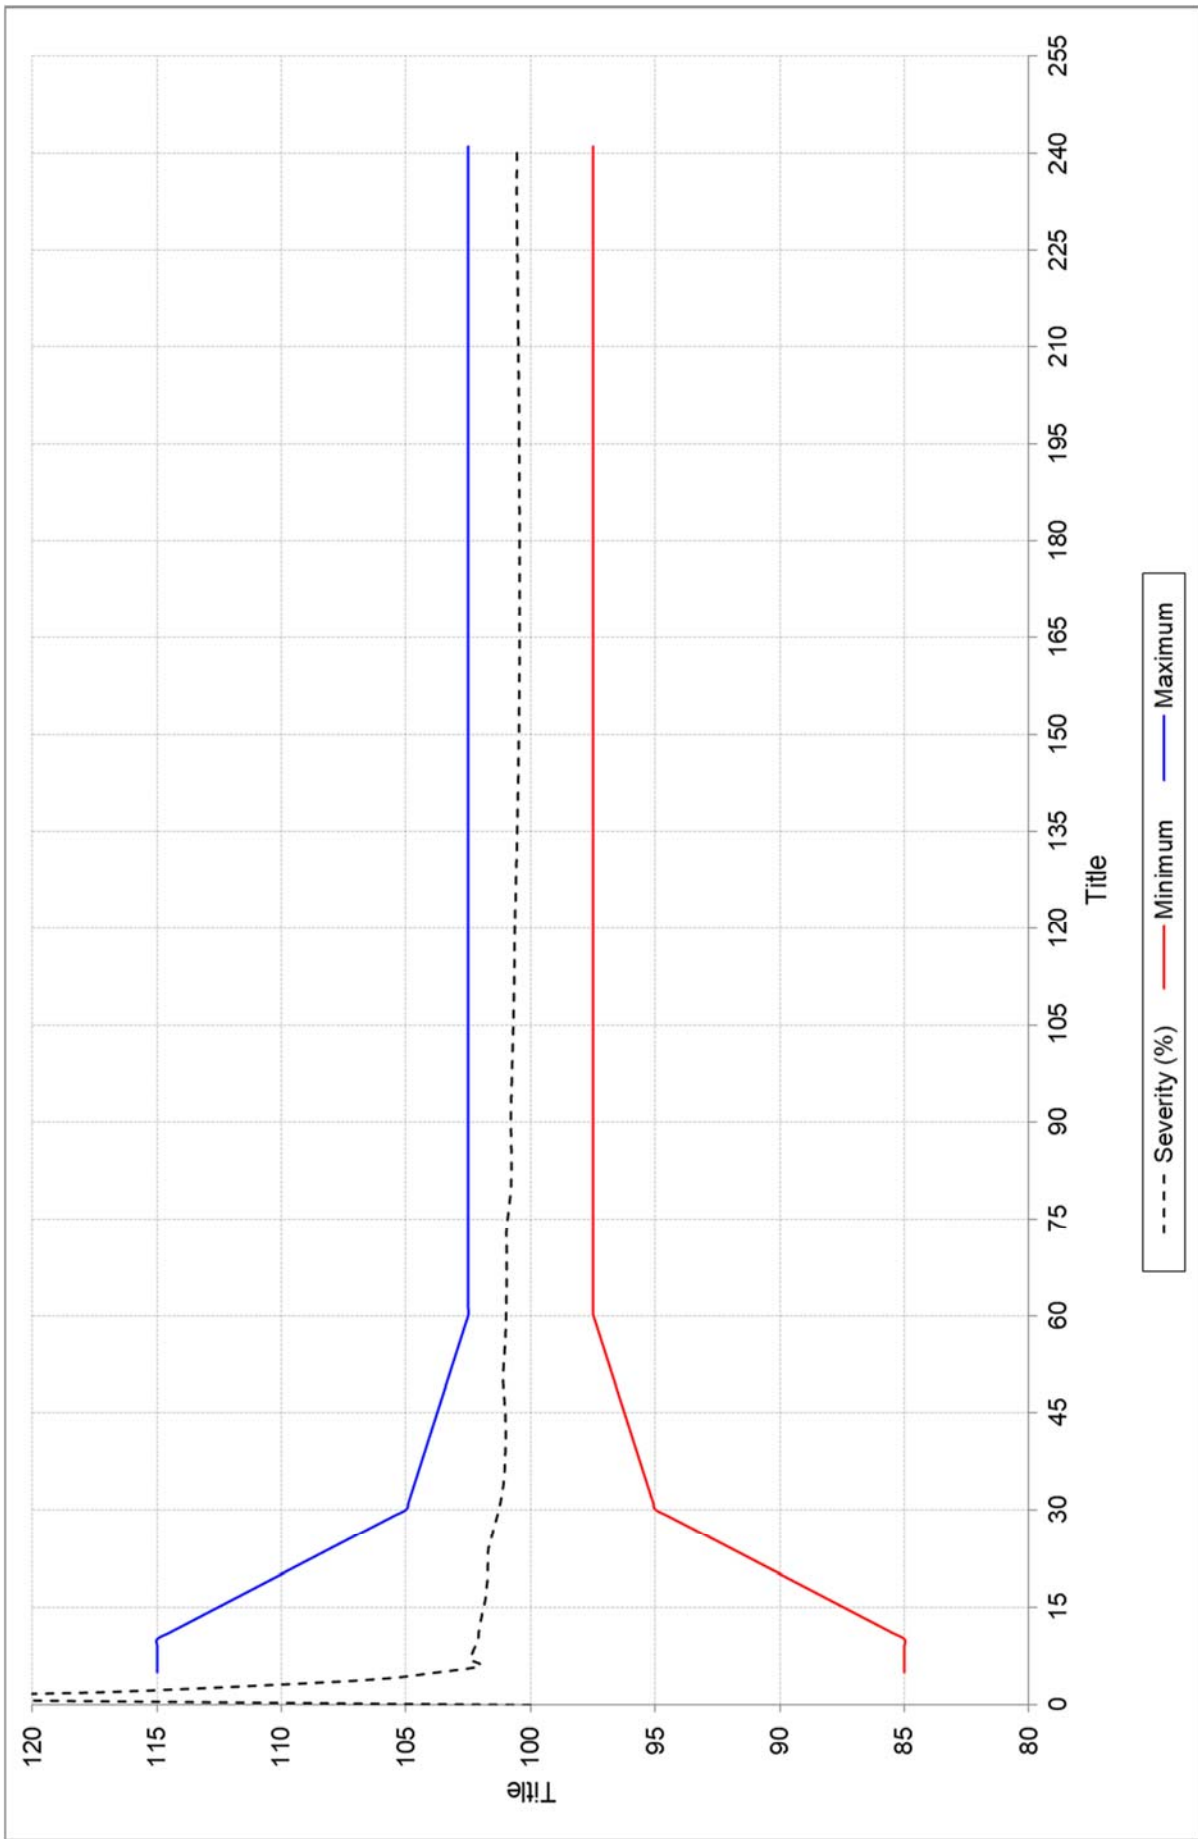
FIGURE 2 – FURNACE SEVERITY

Figure 2 shows the curve of furnace severity versus time during the heating period.

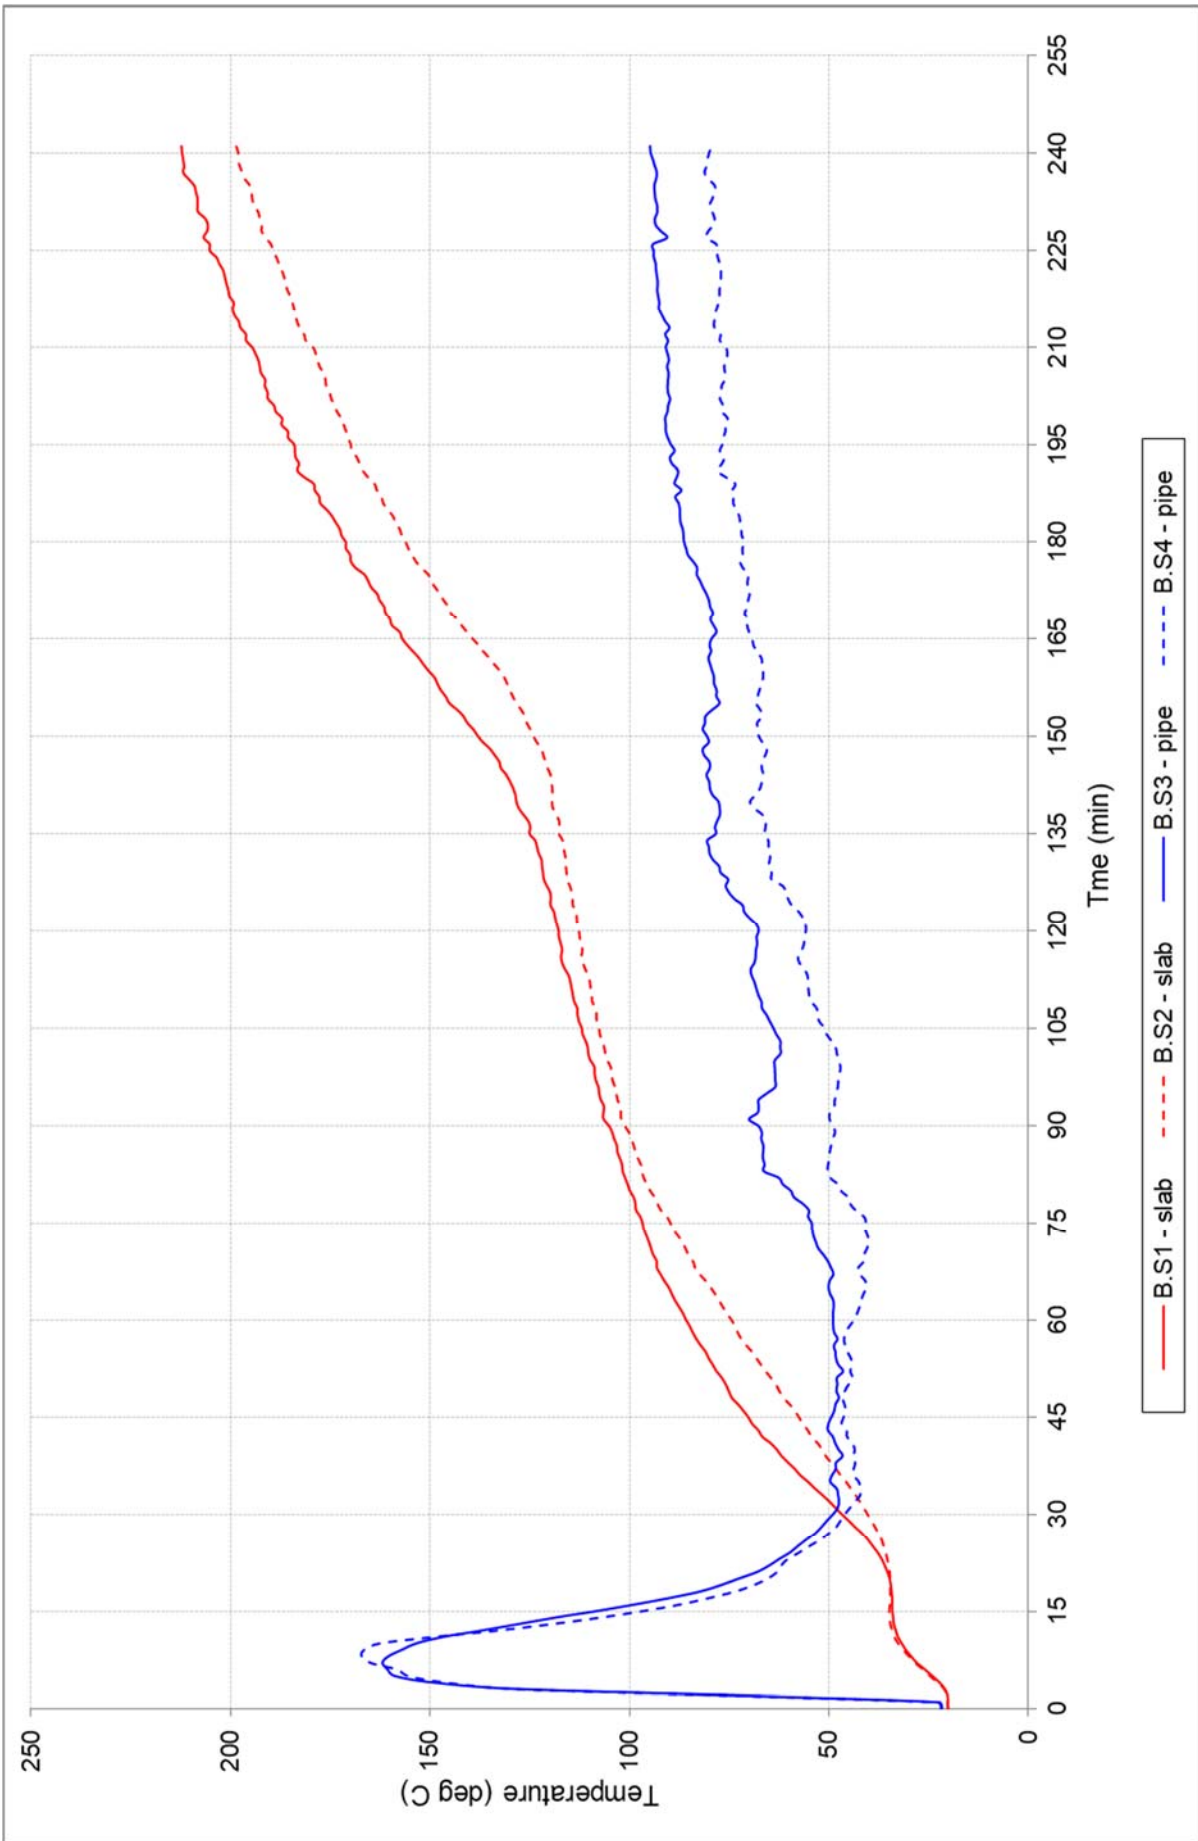
FIGURE 3 – SPECIMEN TEMPERATURE – ASSOCIATED WITH PENETRATION # 1

Figure 3 shows the curve of maximum temperature versus time associated with Penetration 1.

Structural adequacy	-	not applicable
Integrity	-	No failure at 241 minutes
Insulation	-	222 minutes

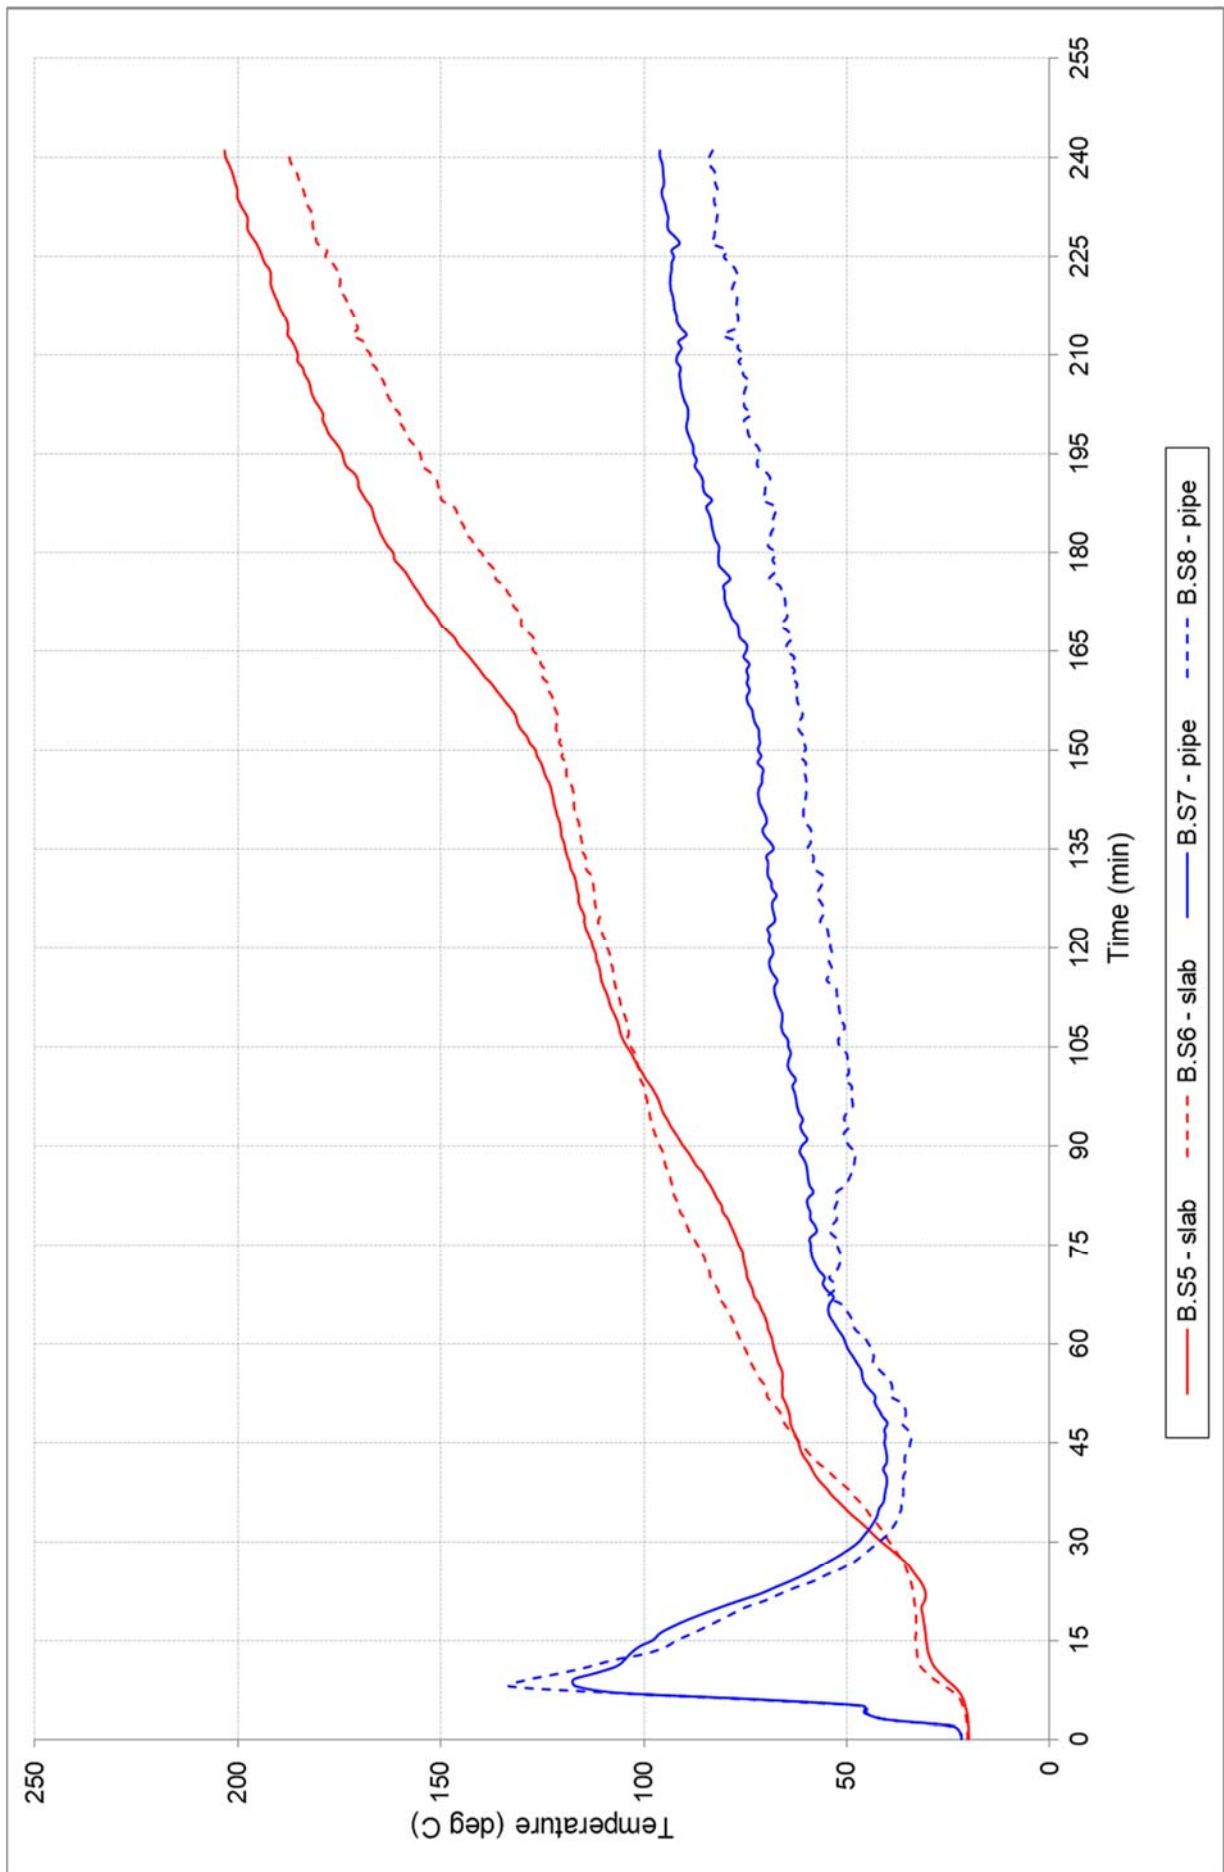
FIGURE 4 – SPECIMEN TEMPERATURE – ASSOCIATED WITH PENETRATION # 2

Figure 4 shows the curve of maximum temperature versus time associated with Penetration 2.

Structural adequacy	-	not applicable
Integrity	-	No failure at 241 minutes
Insulation	-	238 minutes

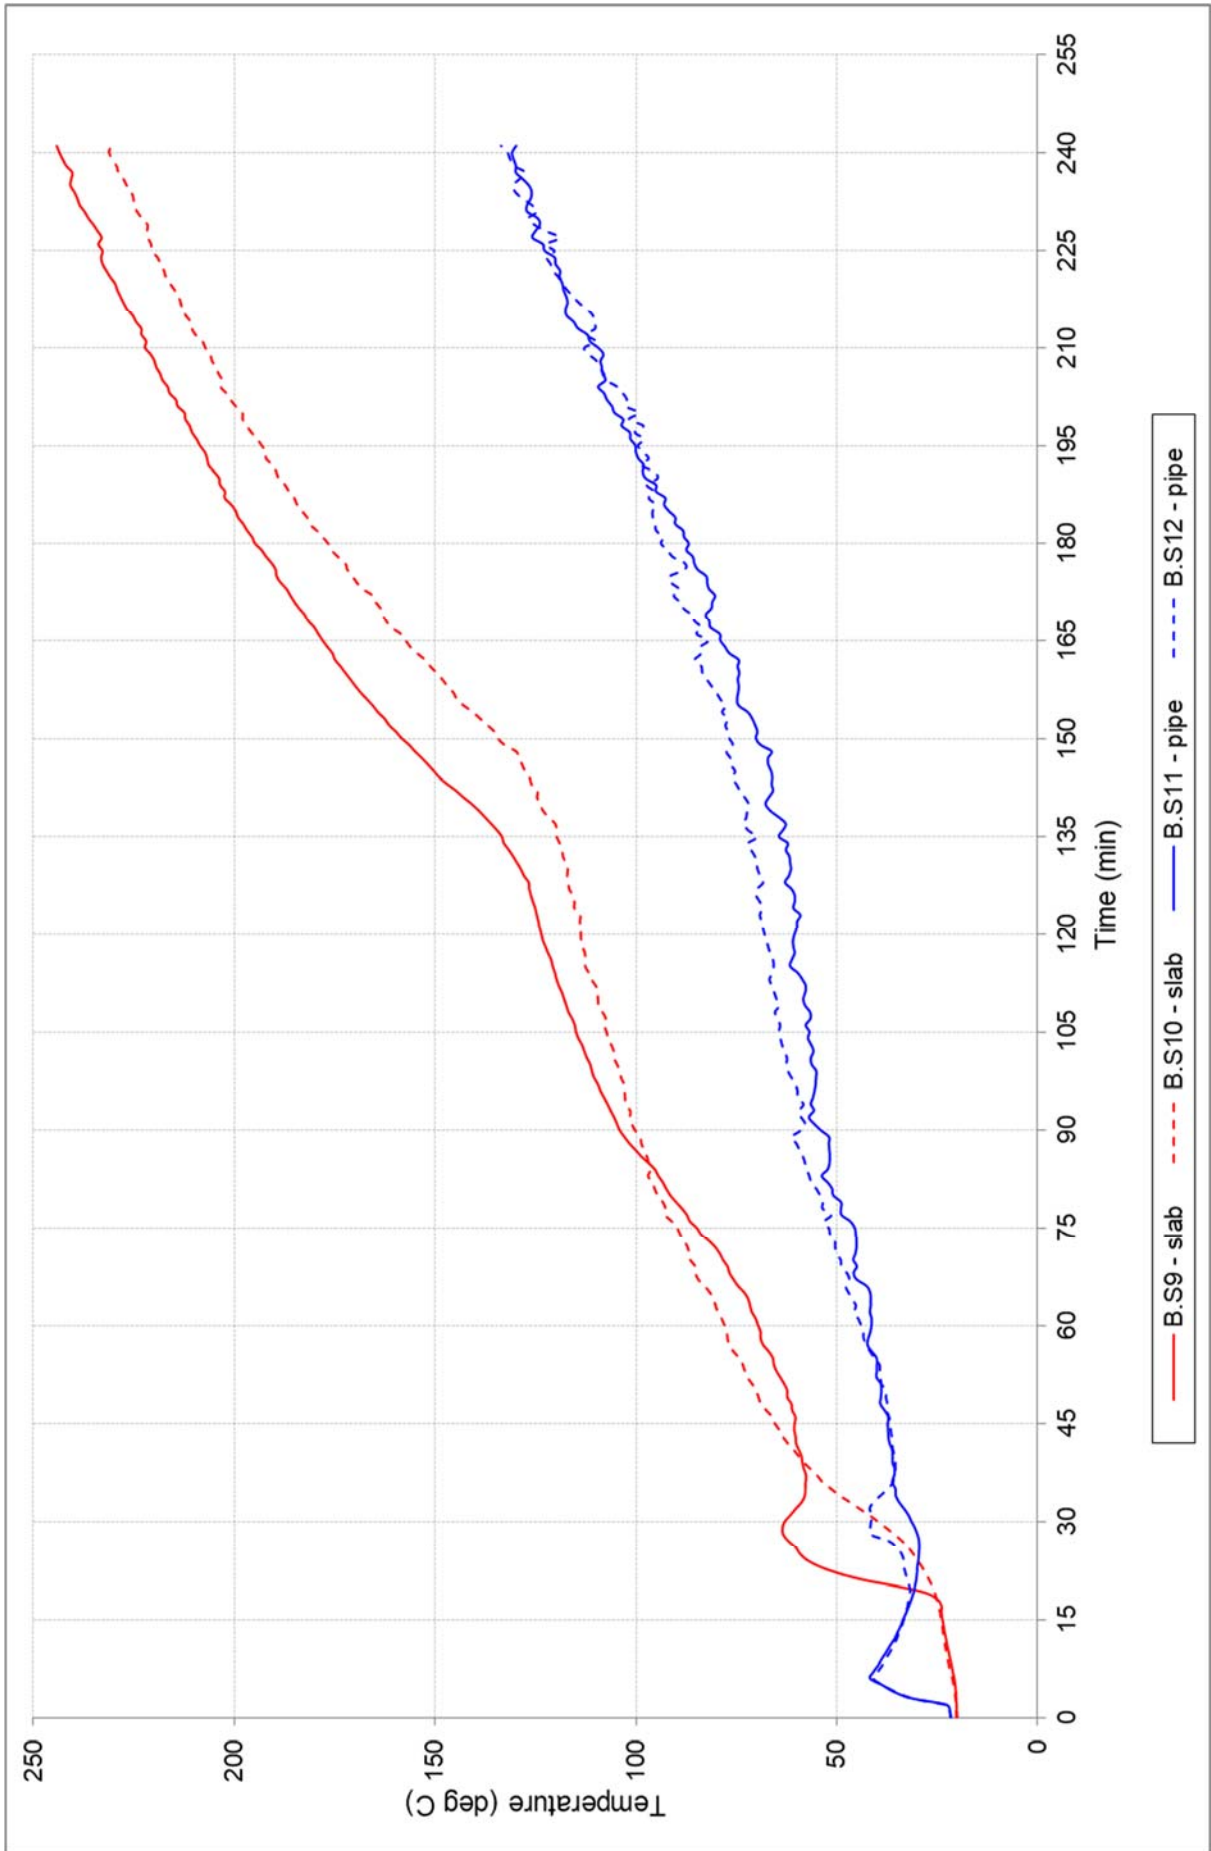
FIGURE 5 – SPECIMEN TEMPERATURE – ASSOCIATED WITH PENETRATION # 3

Figure 5 shows the curve of maximum temperature versus time associated with Penetration 3.

Structural adequacy	-	not applicable
Integrity	-	No failure at 241 minutes
Insulation	-	187 minutes

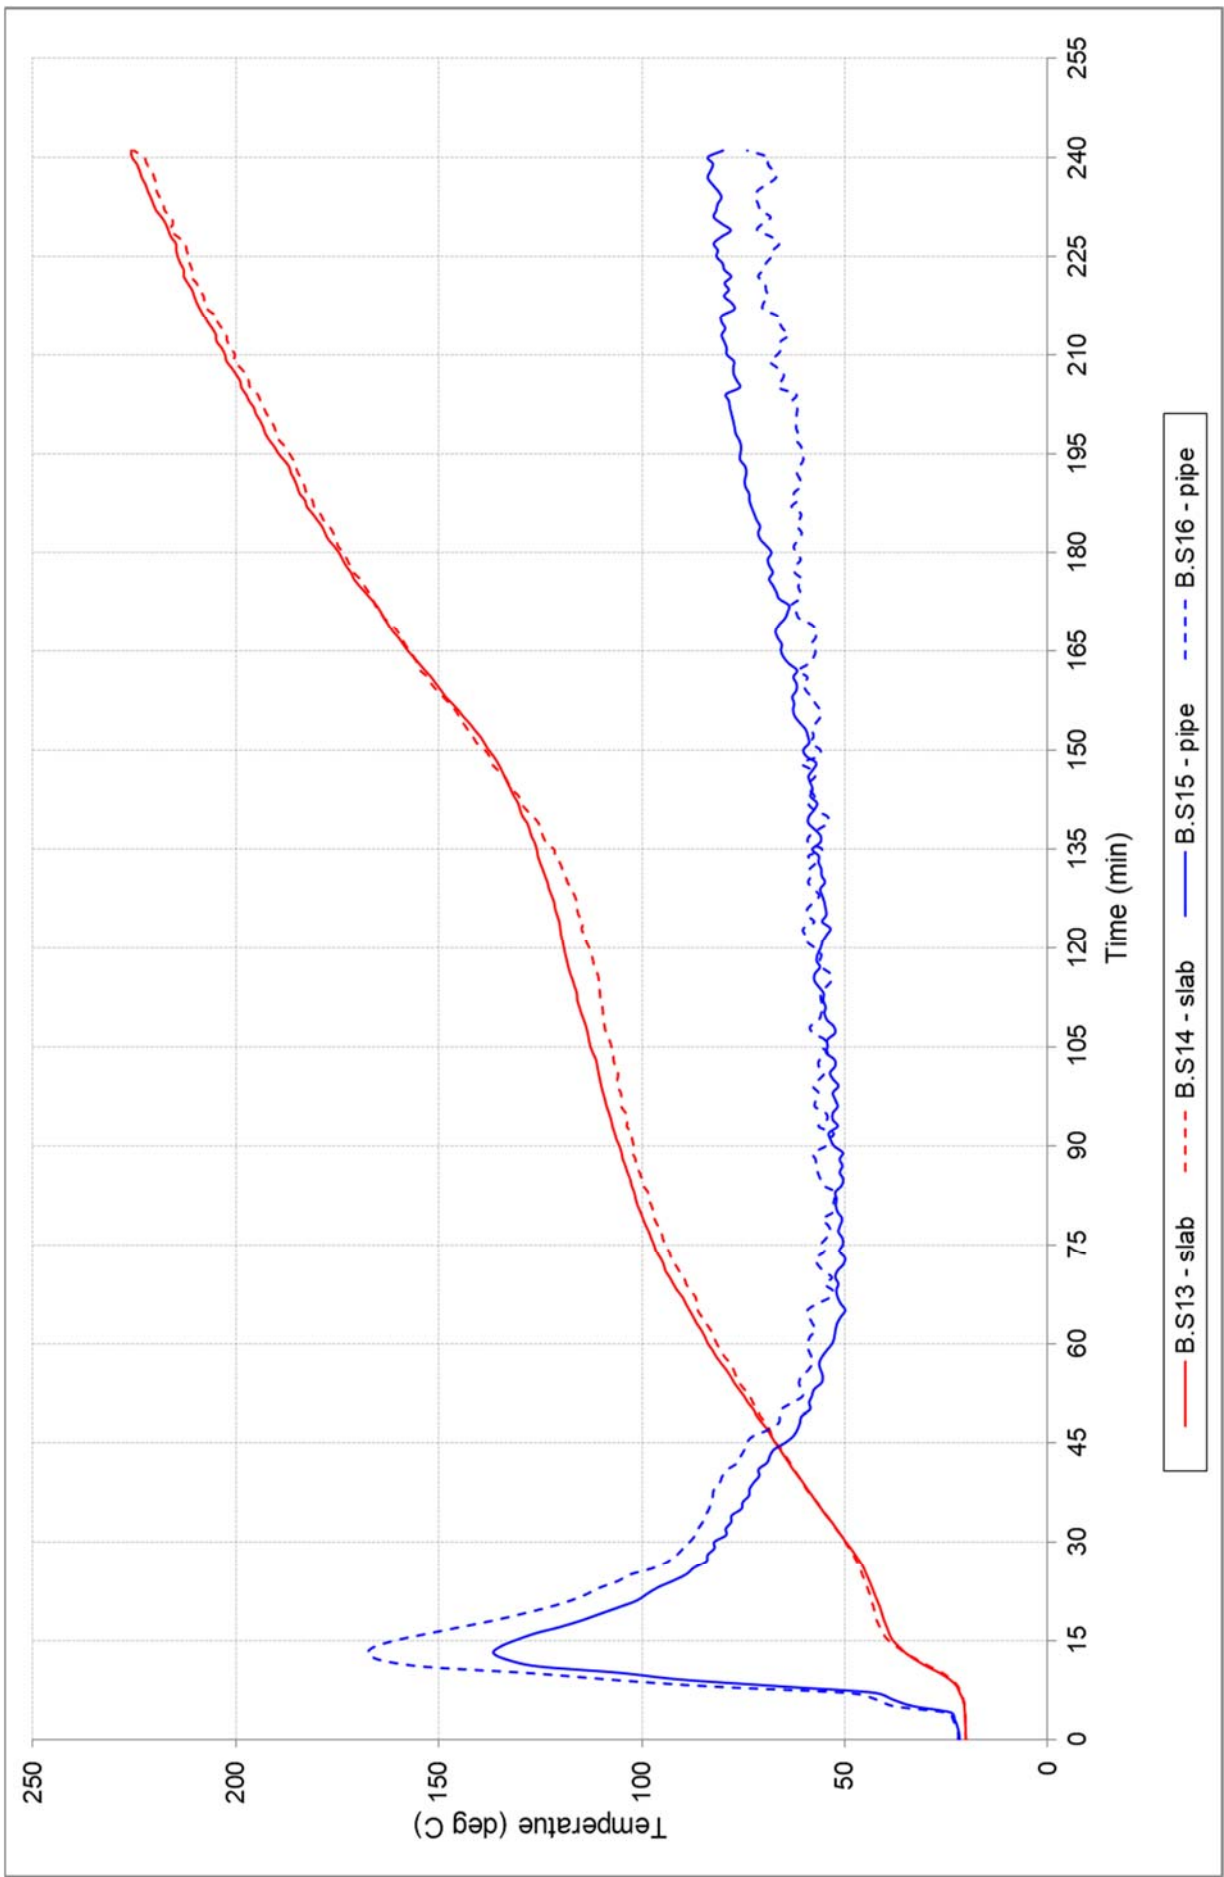
FIGURE 6 – SPECIMEN TEMPERATURE – ASSOCIATED WITH PENETRATION # 4

Figure 6 shows the curve of maximum temperature versus time associated with Penetration 4.

Structural adequacy	-	not applicable
Integrity	-	No failure at 241 minutes
Insulation	-	209 minutes
