# Fire-resistance test on fire collars protecting a concrete floor slab penetrated by services

## Test Report

**Author:** Chris Wojcik  
**Report number:** FSP 1875

## Sponsored Investigation No. FSP 1875

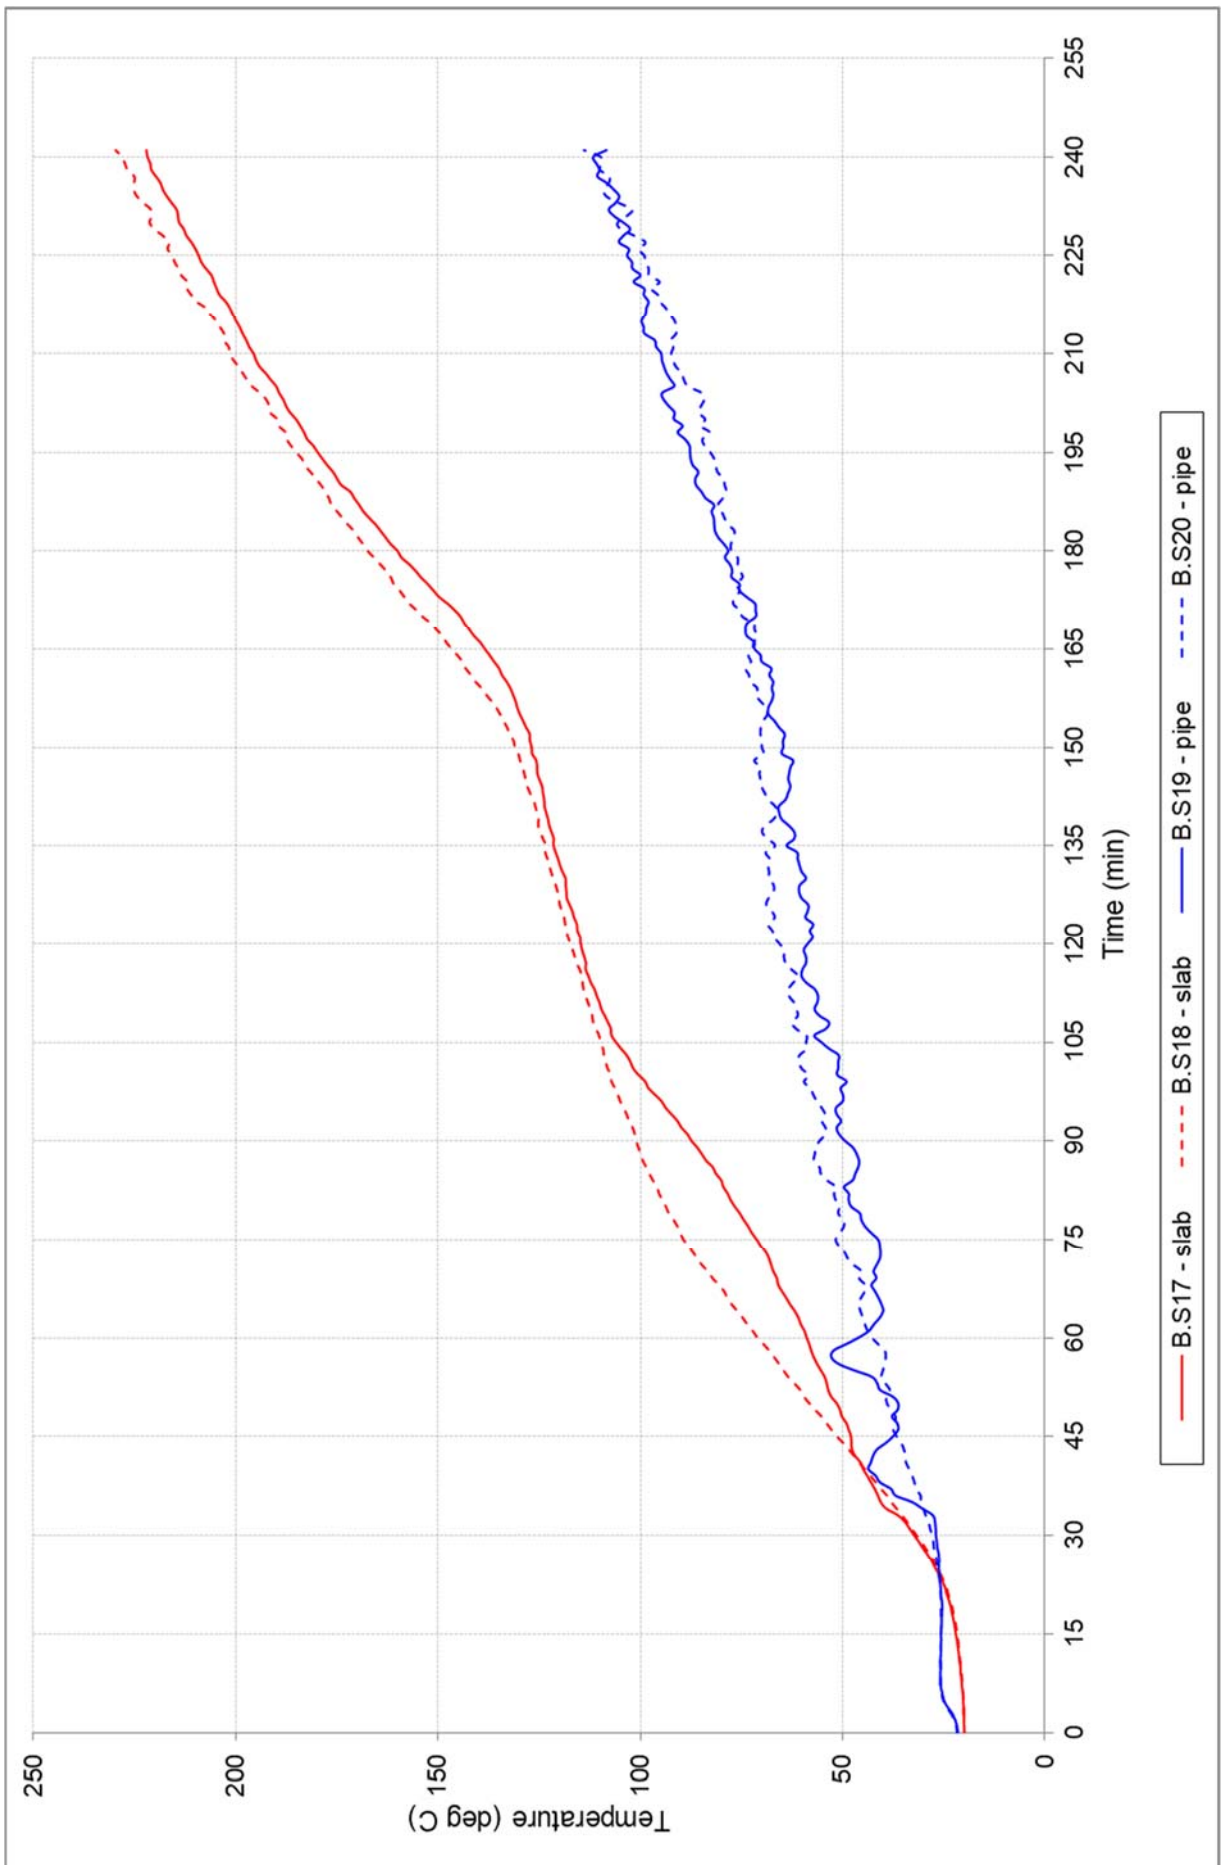
FIGURE 7 – SPECIMEN TEMPERATURE – ASSOCIATED WITH PENETRATION # 5

Figure 7 shows the curve of maximum temperature versus time associated with Penetration 5.

Structural adequacy	-	not applicable
Integrity	-	No failure at 241 minutes
Insulation	-	210 minutes

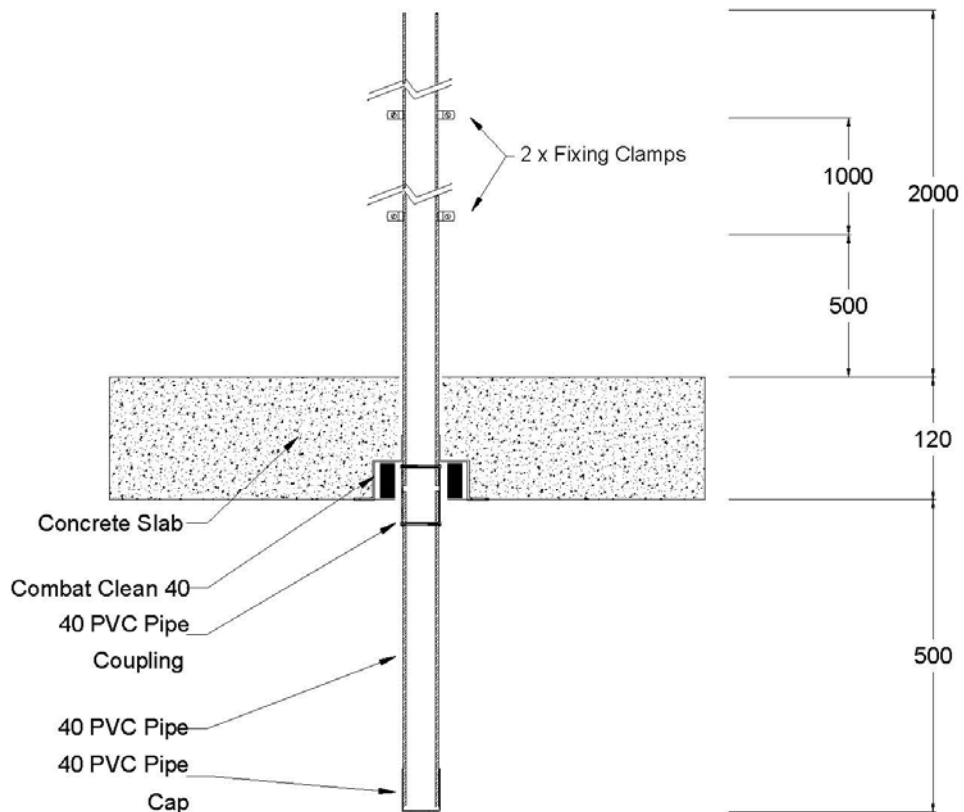
Penetration # 1  
40 PVC Pipe - Stack - Combat Clean 40  
Date: 14 Dec 2017

**DRAWING NUMBERED PENETRATION # 1 – 40MM PVC PIPE – STACK – COMBAT CLEAN 40, DATED 14 DECEMBER 2017, PROVIDED BY COMBAT COLLARS PTY LTD.**

The Combat Clean 40 collar comprised a plastic casing with a 43-mm inner diameter, a 151-mm external diameter base flange, and 0.75-mm thick steel base plate. The 79-mm high collar casing incorporated a layer of 265-mm x 38-mm x 8-mm thick intumescent material, as shown in drawing titled Combat Clean 40 CC-40 provided by Combat Collars Pty Ltd.

The penetrating service comprised a 43-mm outer diameter PVC pipe with a wall thickness of 2-mm fitted through the collar with a coupling located in the collar's sleeve, for a total wall thickness of 4-mm through the collar's sleeve. The pipe projected vertically, 2000-mm away from the unexposed face of the wall and approximately 500-mm into the furnace chamber. The pipe was supported at nominally 500-mm and 1500-mm from the unexposed face of the concrete slab by two support clamps spaced apart at nominally 1000-mm. The pipe was open at the unexposed end and capped on the exposed end with an 40-mm PVC pipe cap.

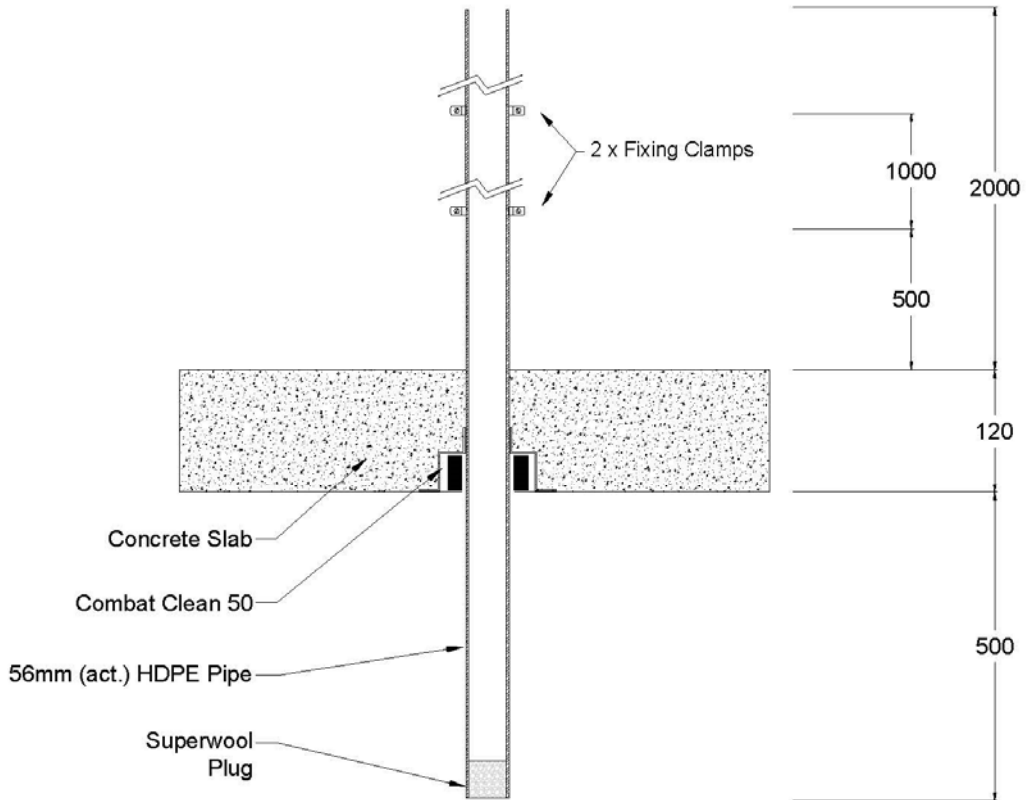
Penetration # 2  
56mm (act.) HDPE Pipe - Stack - Combat Clean 50  
Date: 14 Dec 2017

**DRAWING NUMBERED PENETRATION # 2 – 56MM (ACT.) HDPE PIPE – STACK – COMBAT CLEAN 50,  
DATED 14 DECEMBER 2017, PROVIDED BY COMBAT COLLARS PTY LTD.**

The Combat Clean 50 collar comprised a plastic casing with a 56-mm inner diameter, a 151-mm external diameter base flange and 0.75-mm thick steel base plate. The 79-mm high collar casing incorporated a layer of 265-mm x 38-mm x 8-mm thick intumescent material, as shown in drawing titled Combat Clean 50 CC-50 by Combat Collars Pty Ltd.

The penetrating service comprised a 56-mm outer diameter HDPE pipe with a wall thickness of 3.1-mm fitted through the collar. The pipe projected vertically, 2000-mm away from the unexposed face of the wall and approximately 500-mm into the furnace chamber. The pipe was supported at nominally 500-mm and 1500-mm from the unexposed face of the concrete slab by two support clamps spaced apart at nominally 1000-mm. The pipe was open at the unexposed end and capped on the exposed end with an 56-mm PVC pipe cap.

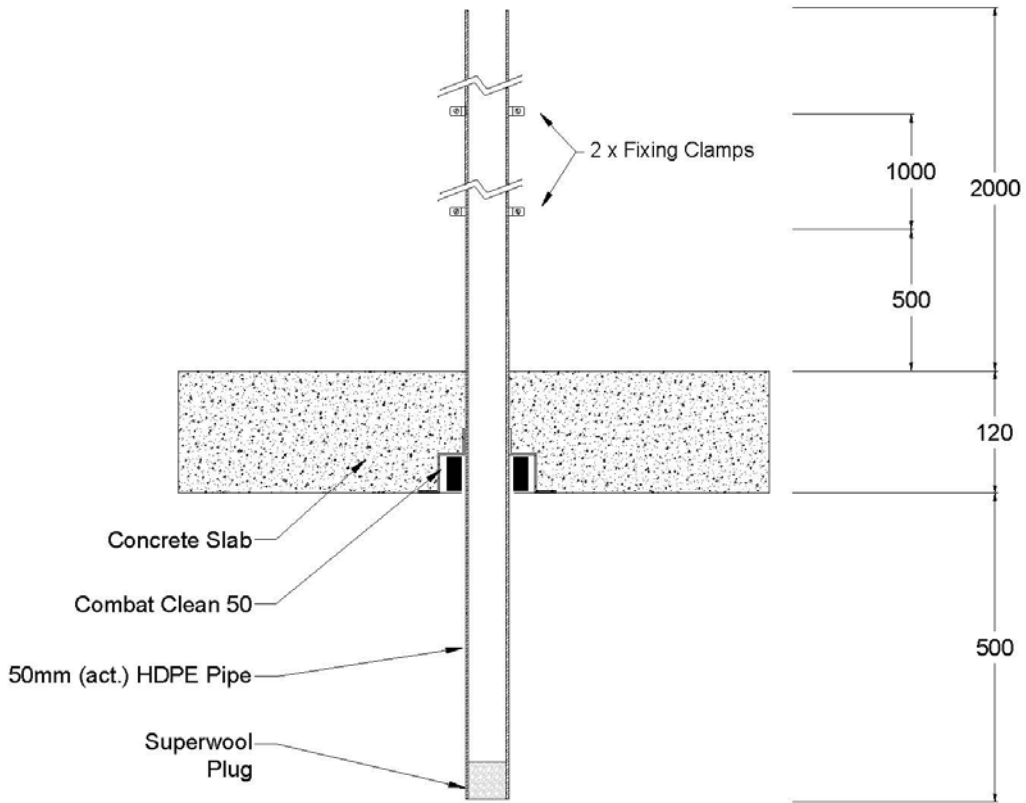
Penetration # 3  
50mm (act.) HDPE Pipe - Stack - Combat Clean 50  
Date: 14 Dec 2017

**DRAWING NUMBERED PENETRATION # 3 – 50MM (ACT.) HDPE PIPE – STACK – COMBAT CLEAN 50,  
DATED 14 DECEMBER 2017, PROVIDED BY COMBAT COLLARS PTY LTD.**

The Combat Clean 50 collar comprised a plastic casing with a 56-mm inner diameter, a 151-mm external diameter base flange, and 0.75-mm thick steel base plate. The 79-mm high collar casing incorporated a layer of 265-mm x 38-mm x 8-mm thick intumescent material, as shown in drawing titled Combat Clean 50 CC-50 by Combat Collars Pty Ltd.

The penetrating service comprised a 50-mm diameter HDPE pipe with a wall thickness of 3.5-mm fitted through the collars sleeve. The pipe projected vertically, 2000-mm away from the unexposed face of the concrete slab and approximately 500-mm into the furnace chamber. The pipe was supported at nominally 500-mm and 1500-mm from the unexposed face of the concrete slab by two support clamps spaced apart at nominally 1000-mm. The pipe was open at the unexposed end and capped on the exposed end with a Superwool plug.

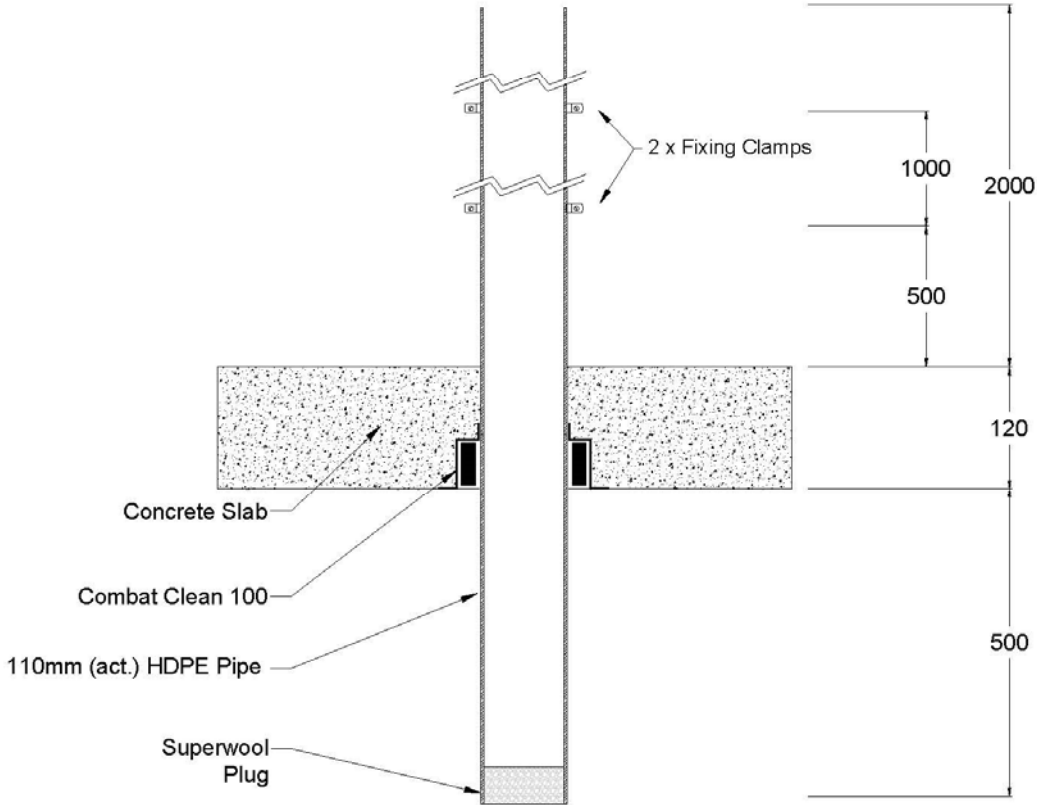
Penetration # 4  
110mm (act.) HDPE Pipe - Stack - Combat Clean 100  
Date: 14 Dec 2017

**DRAWING NUMBERED PENETRATION # 4 – 110MM (ACT.) HDPE PIPE – STACK – COMBAT CLEAN 100, DATED 14 DECEMBER 2017, PROVIDED BY COMBAT COLLARS PTY LTD.**

The Combat Clean 100 collar comprised a plastic casing with a 110-mm inner diameter, a 210-mm external diameter base flange, and 0.75-mm thick steel base plate. The 80-mm high collar casing incorporated a layer of 443-mm x 48-mm x 12-mm thick intumescent material, as shown in drawing titled Combat Clean 100 CC-100 provided by Combat Collars Pty Ltd.

The penetrating service comprised a 110-mm diameter HDPE pipe with a wall thickness of 5-mm fitted through the collar. The pipe projected vertically, 2000-mm away from the unexposed face of the concrete slab and approximately 500-mm into the furnace chamber. The pipe was supported at nominally 500-mm and 1500-mm from the unexposed face of the concrete slab by two support clamps spaced apart at nominally 1000-mm. The pipe was open at the unexposed end and capped on the exposed end with a Superwool Plug.

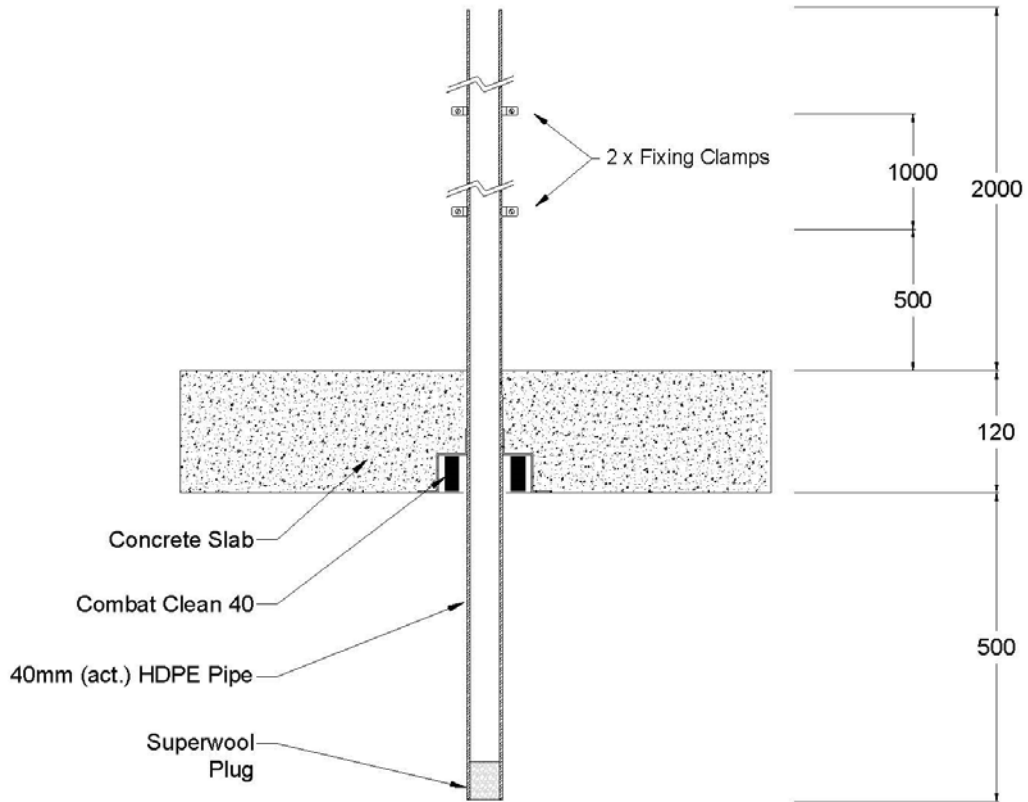
Penetration # 5  
40mm (act.) HDPE Pipe - Stack - Combat Clean 40  
Date: 14 Dec 2017

**DRAWING NUMBERED PENETRATION # 5 – 40MM (ACT.) HDPE PIPE – STACK – COMBAT CLEAN 40,  
DATED 14 DECEMBER 2017, PROVIDED BY COMBAT COLLARS PTY LTD.**

The Combat Clean 40 collar comprised a plastic casing with a 43-mm inner diameter, a 151-mm external diameter base flange, and 0.75-mm thick steel base plate. The 79-mm high collar casing incorporated a layer of 265-mm x 38-mm x 8-mm thick intumescent material, as shown in drawing titled Combat Clean 40 CC-40 provided by Combat Collars Pty Ltd.

The penetrating service comprised a 40-mm diameter HDPE pipe with a wall thickness of 3.5-mm fitted through the collar. The pipe projected vertically, 2000-mm away from the unexposed face of the concrete slab and approximately 500-mm into the furnace chamber. The pipe was supported at nominally 500-mm and 1500-mm from the unexposed face of the concrete slab by two support clamps spaced apart at nominally 1000-mm. The pipe was open at the unexposed end and capped on the exposed end with a Superwool plug.

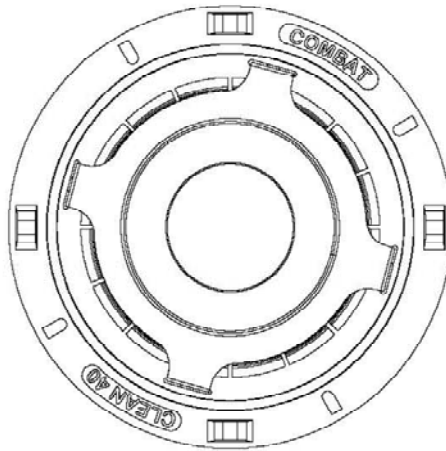
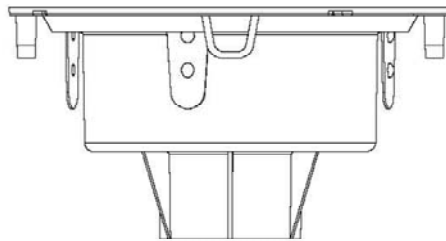
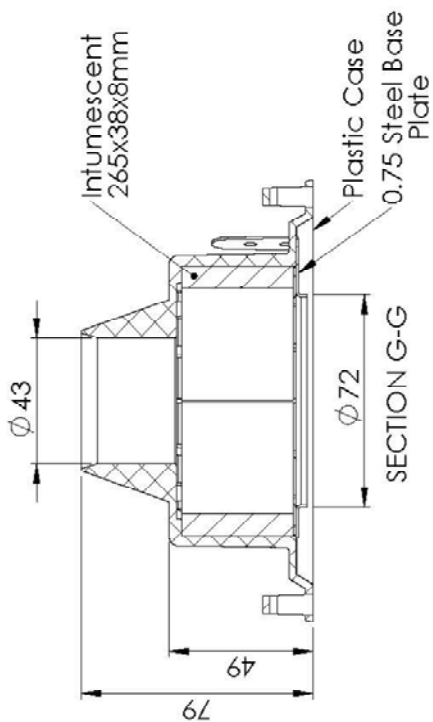
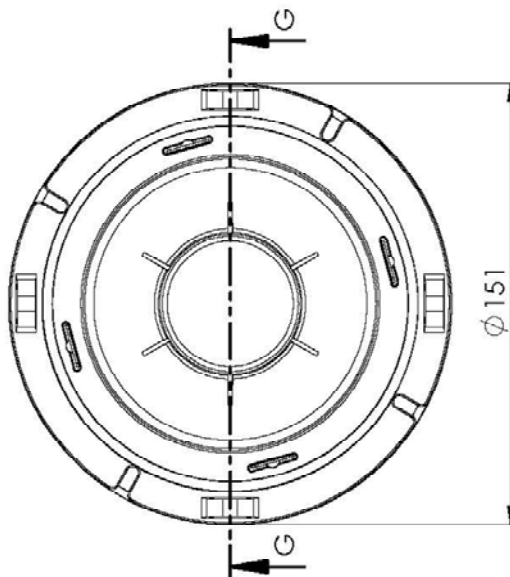
# COMBAT COLLAR CLEAN 40 CC40

DRAWING TITLED COMBAT CLEAN 40 CC-40, UNDATED, PROVIDED BY COMBAT COLLARS PTY LTD.

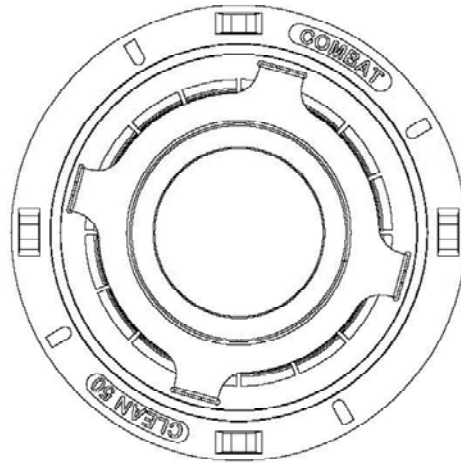
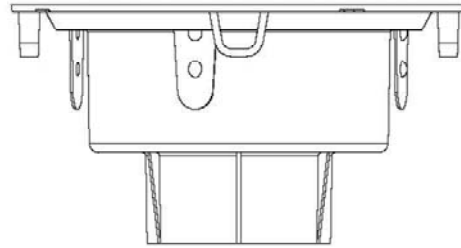
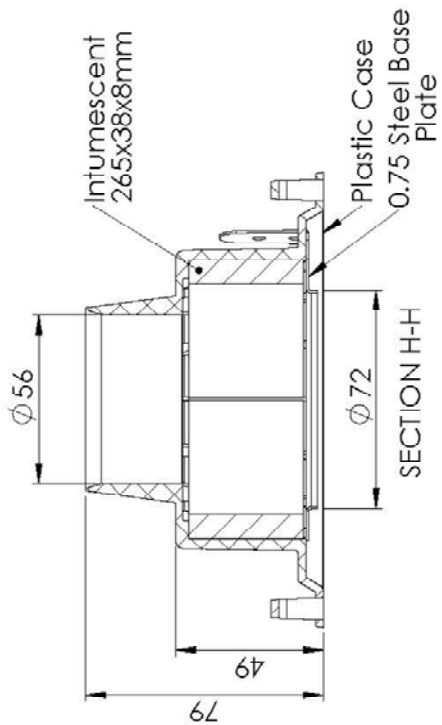
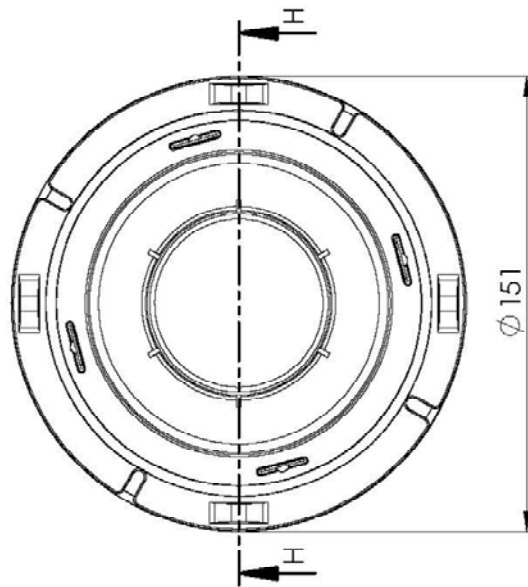
# COMBAT COLLAR CLEAN 50 CC50

DRAWING TITLED COMBAT CLEAN 50 CC-50, UNDATED, PROVIDED BY COMBAT COLLARS PTY LTD.

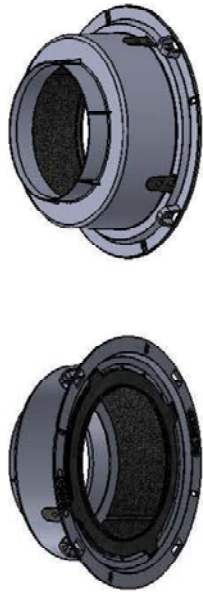
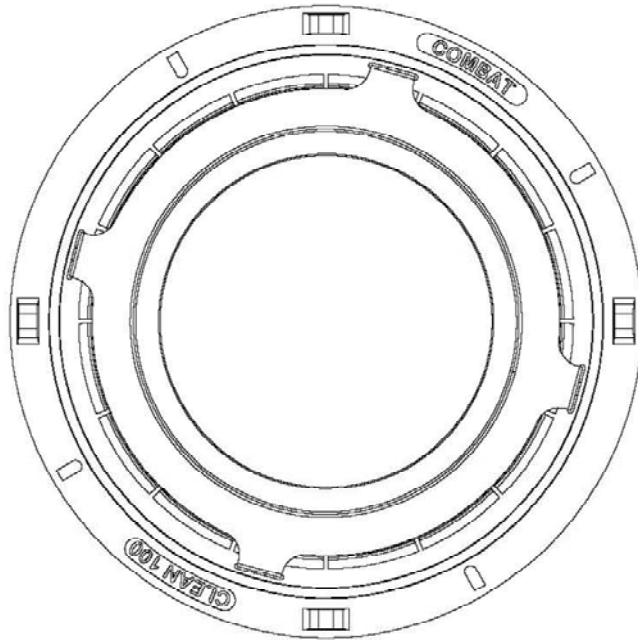
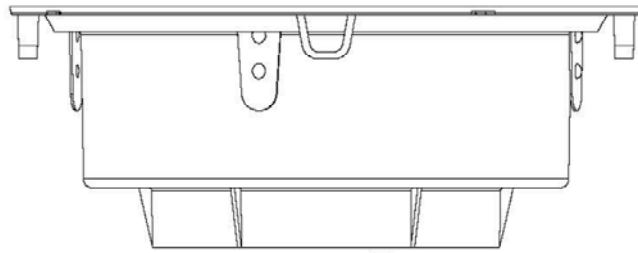
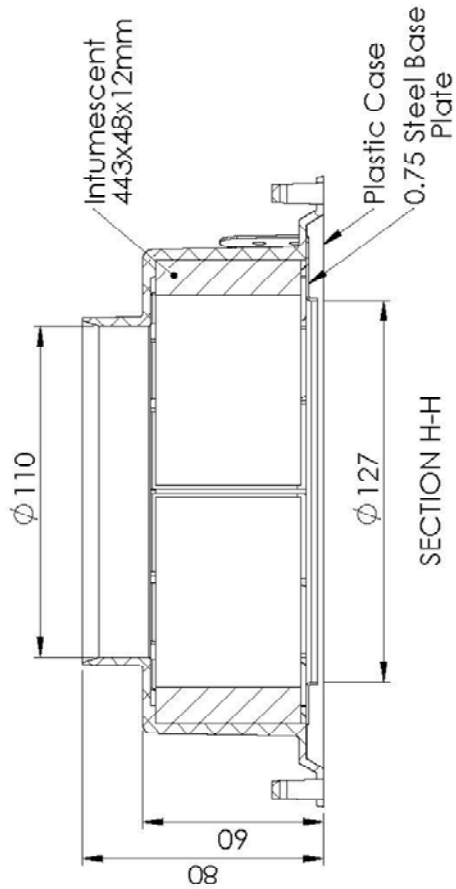
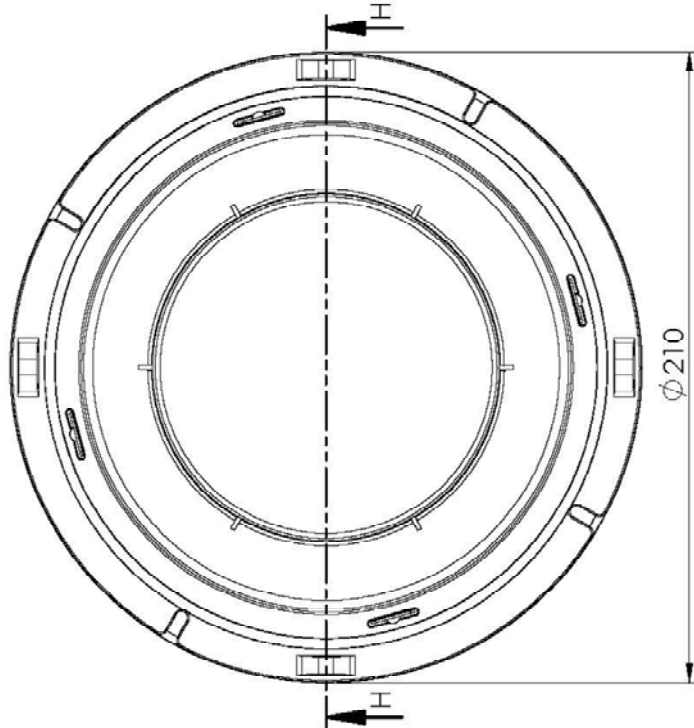
# COMBAT COLLAR CLEAN 100 CC100

DRAWING TITLED COMBAT CLEAN 100 CC-100, UNDATED, PROVIDED BY COMBAT COLLARS PTY LTD.
